Water Main Replacement Work A Field Example

July/August 2012

Miguel A. Del Toral

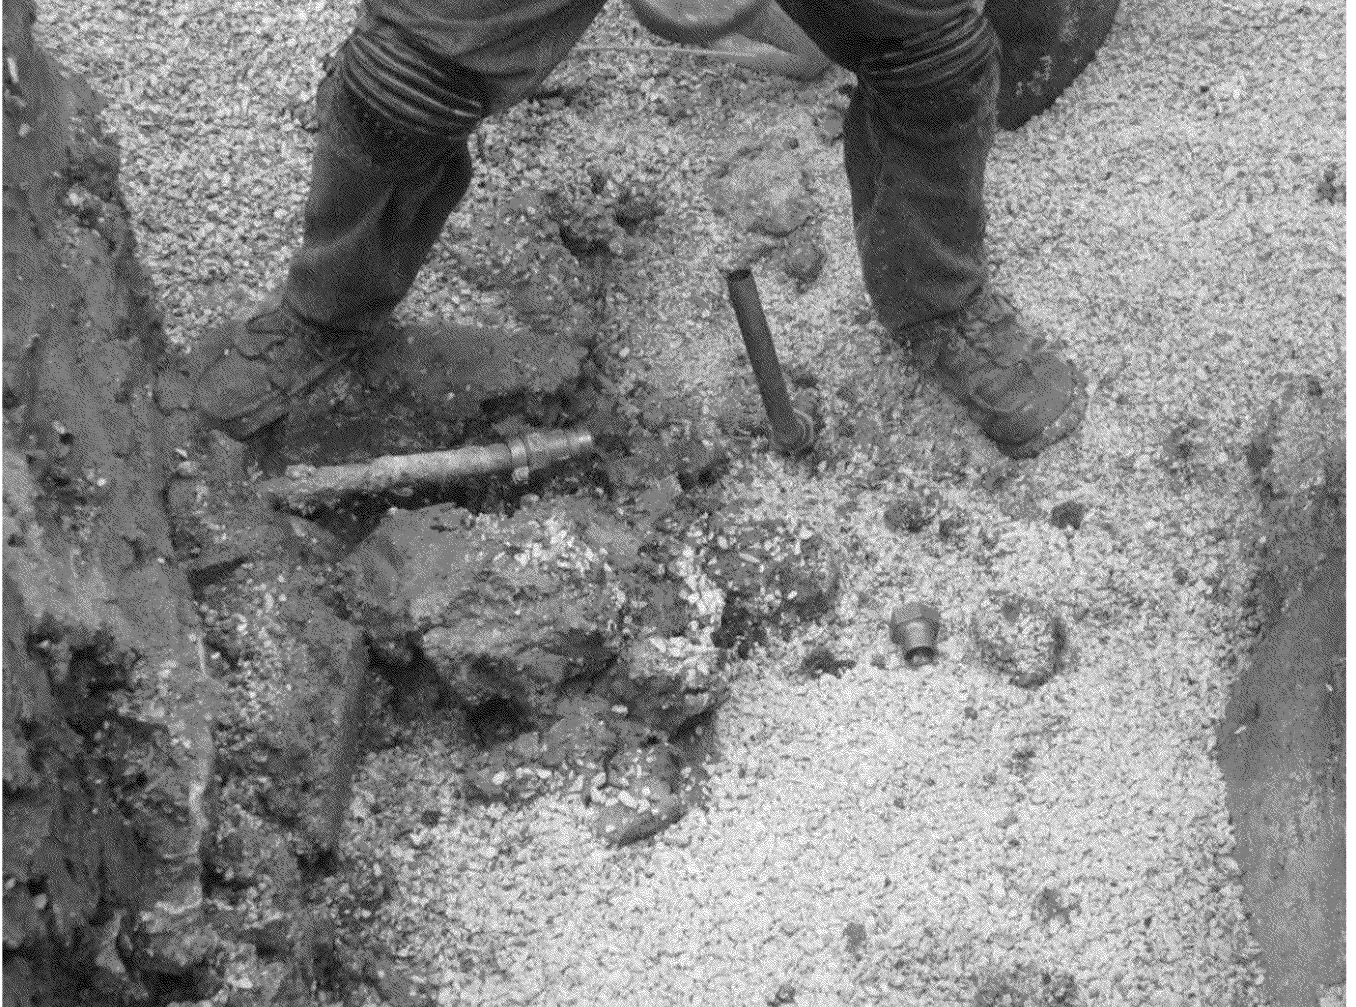
The final cut copper pipe.

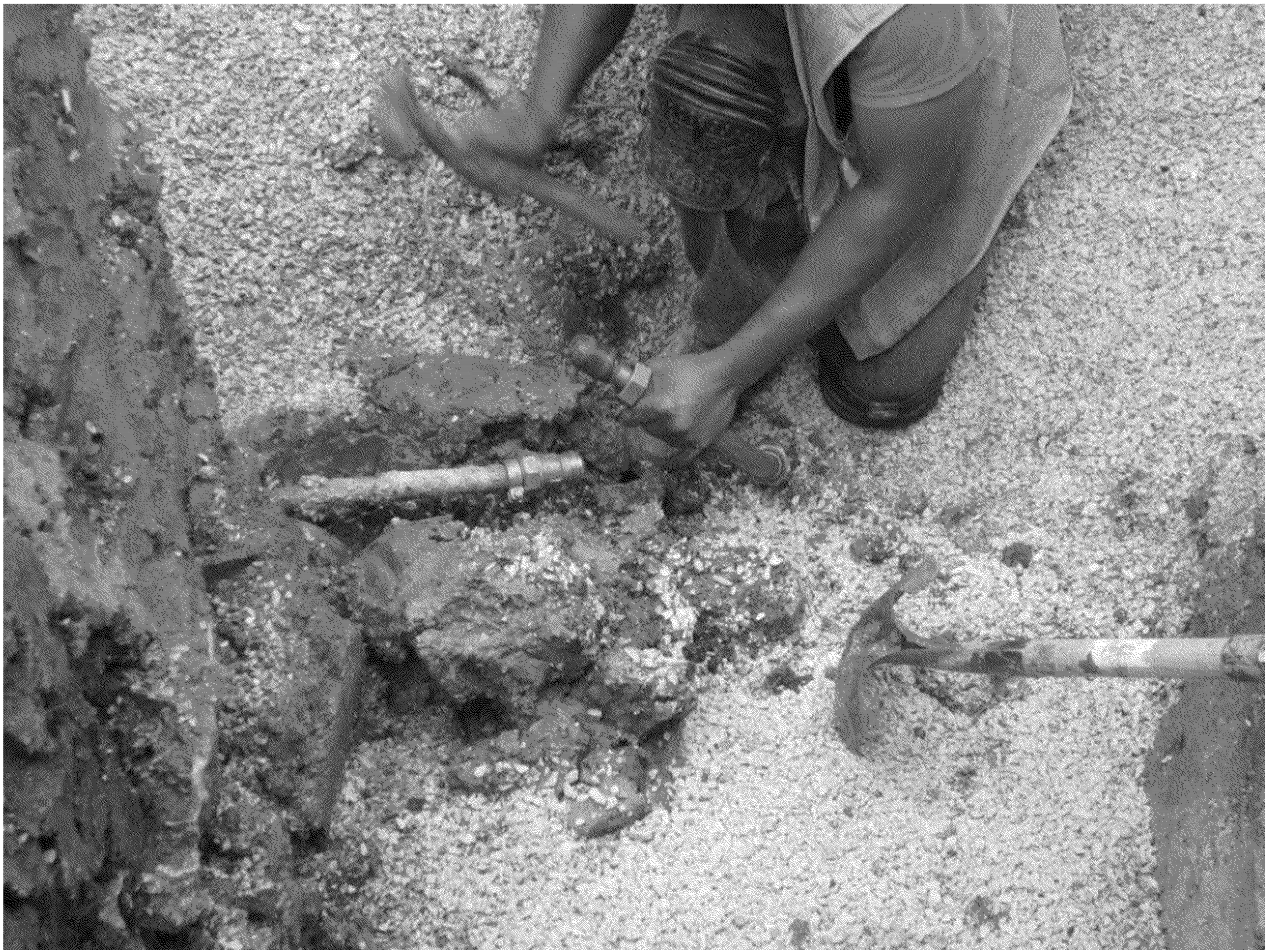
The bronze connector is slid onto the copper pipe and the end of the copper pipe is flared.

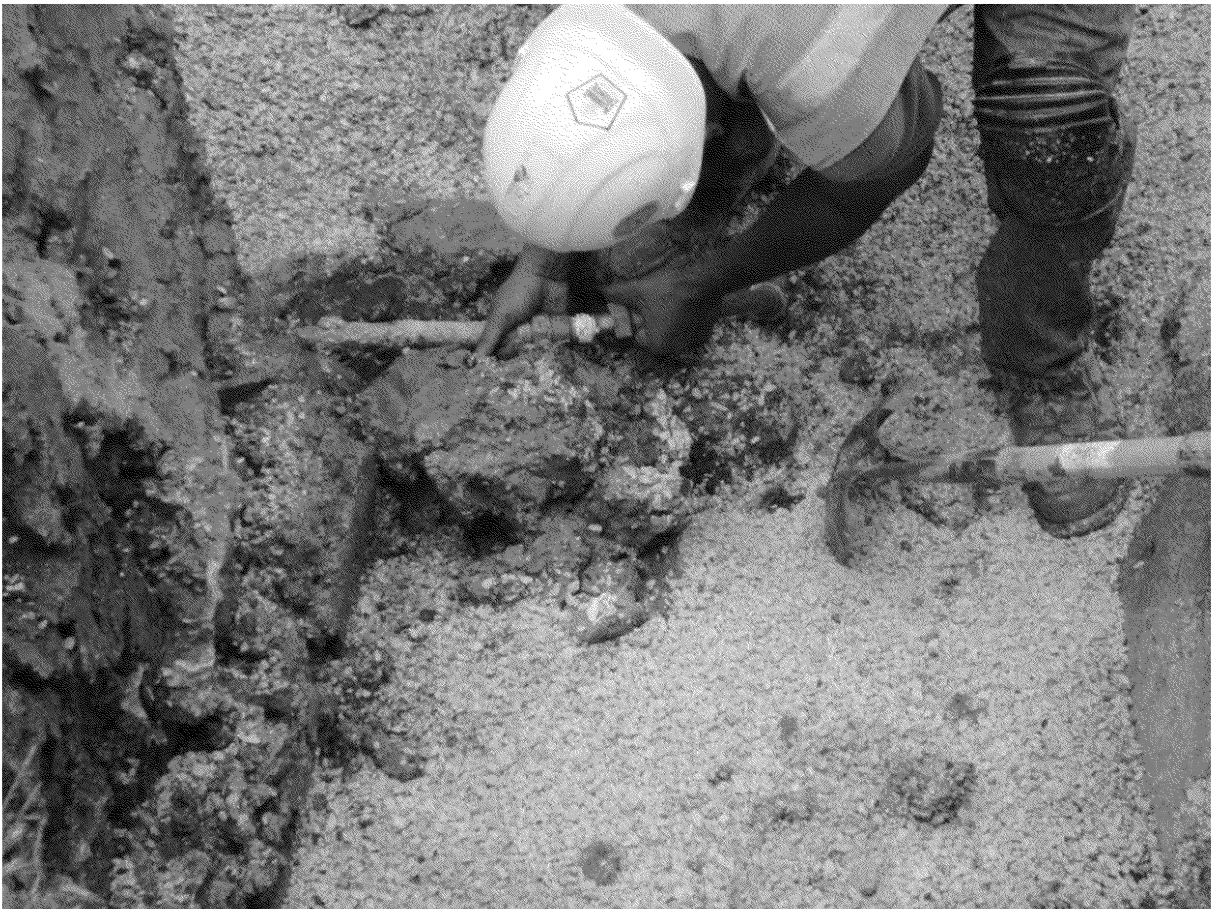
The lead and copper pipe are connected. In this case a dielectric fitting was not used, potentially increasing the risk of galvanic corrosion of the lead pipe.

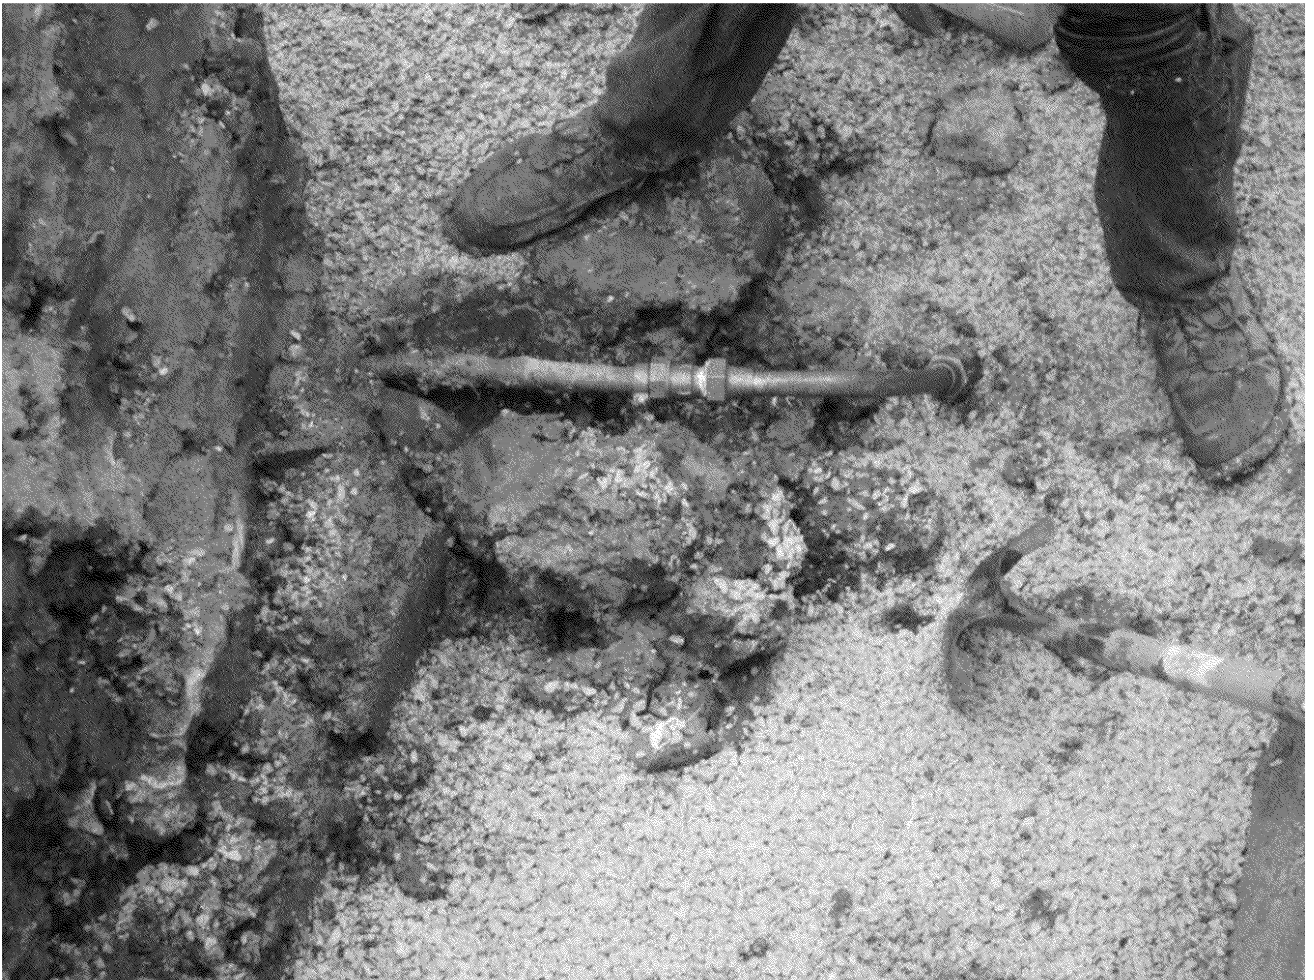
Once the pipes are joined, the valve is opened to check for leaks.

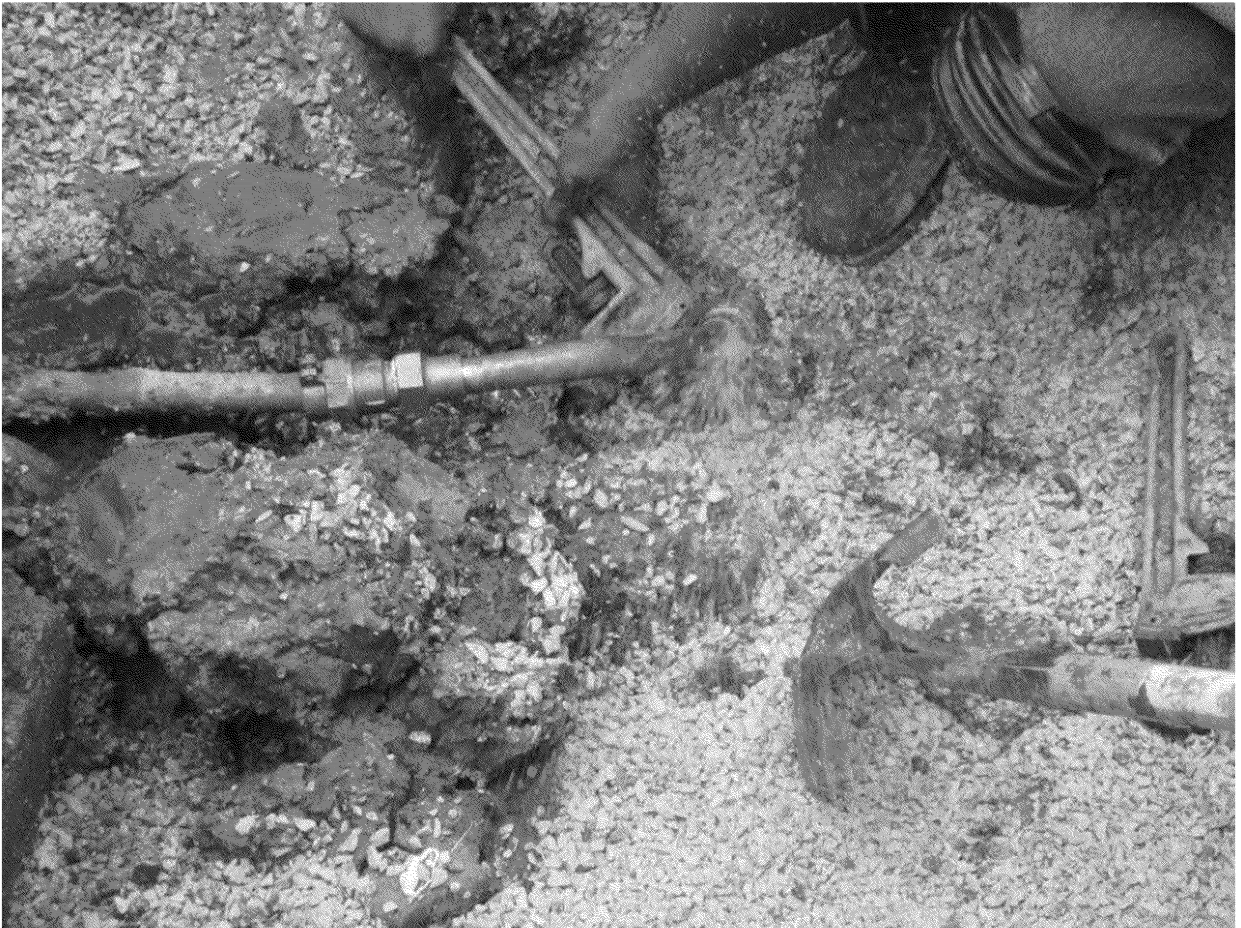
The new connection to the main was not sufficiently tightened, so water sprays out once the valve is opened.

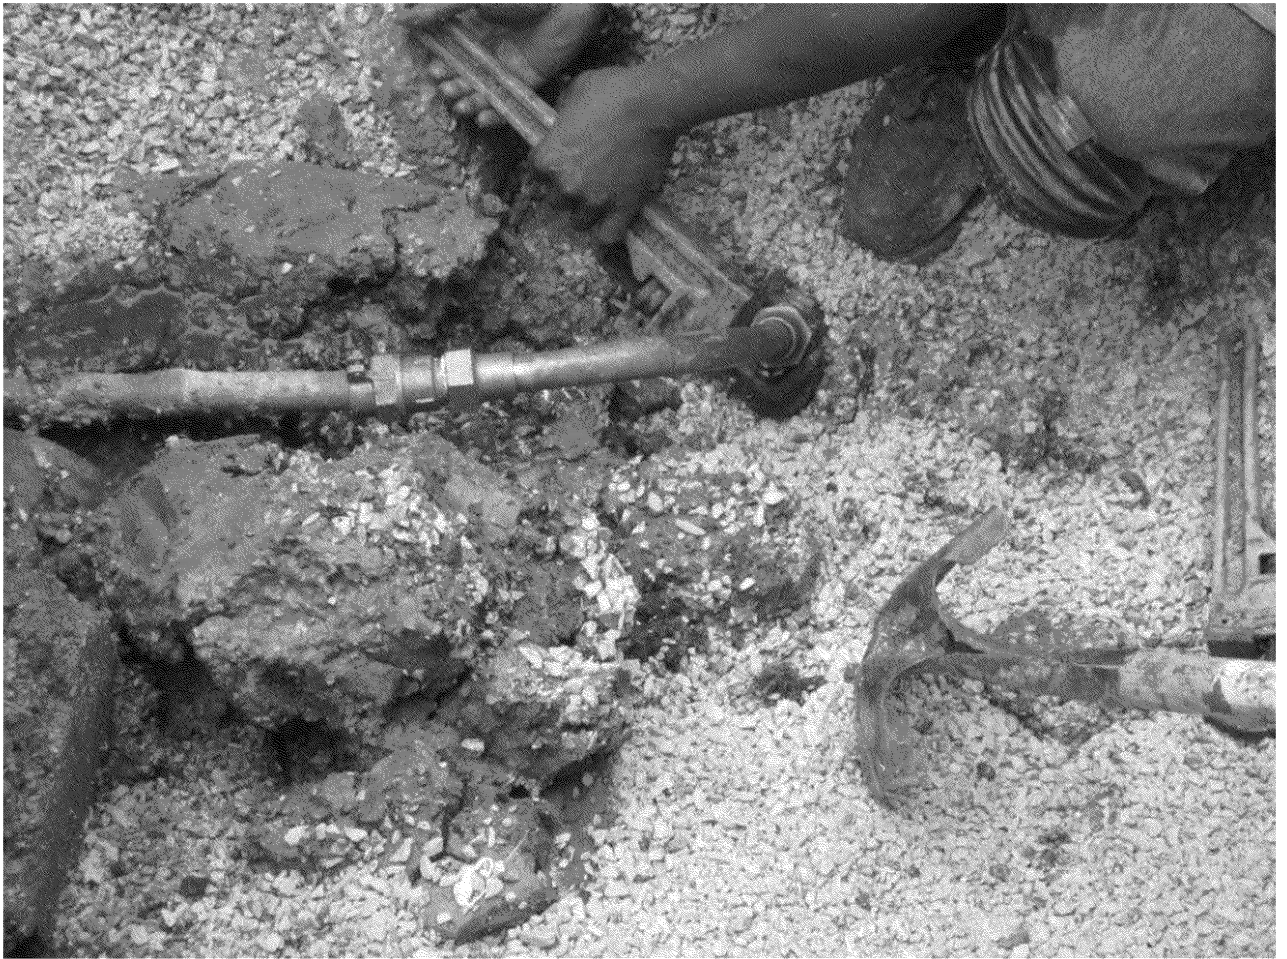
Tightening the connection stops the leak.

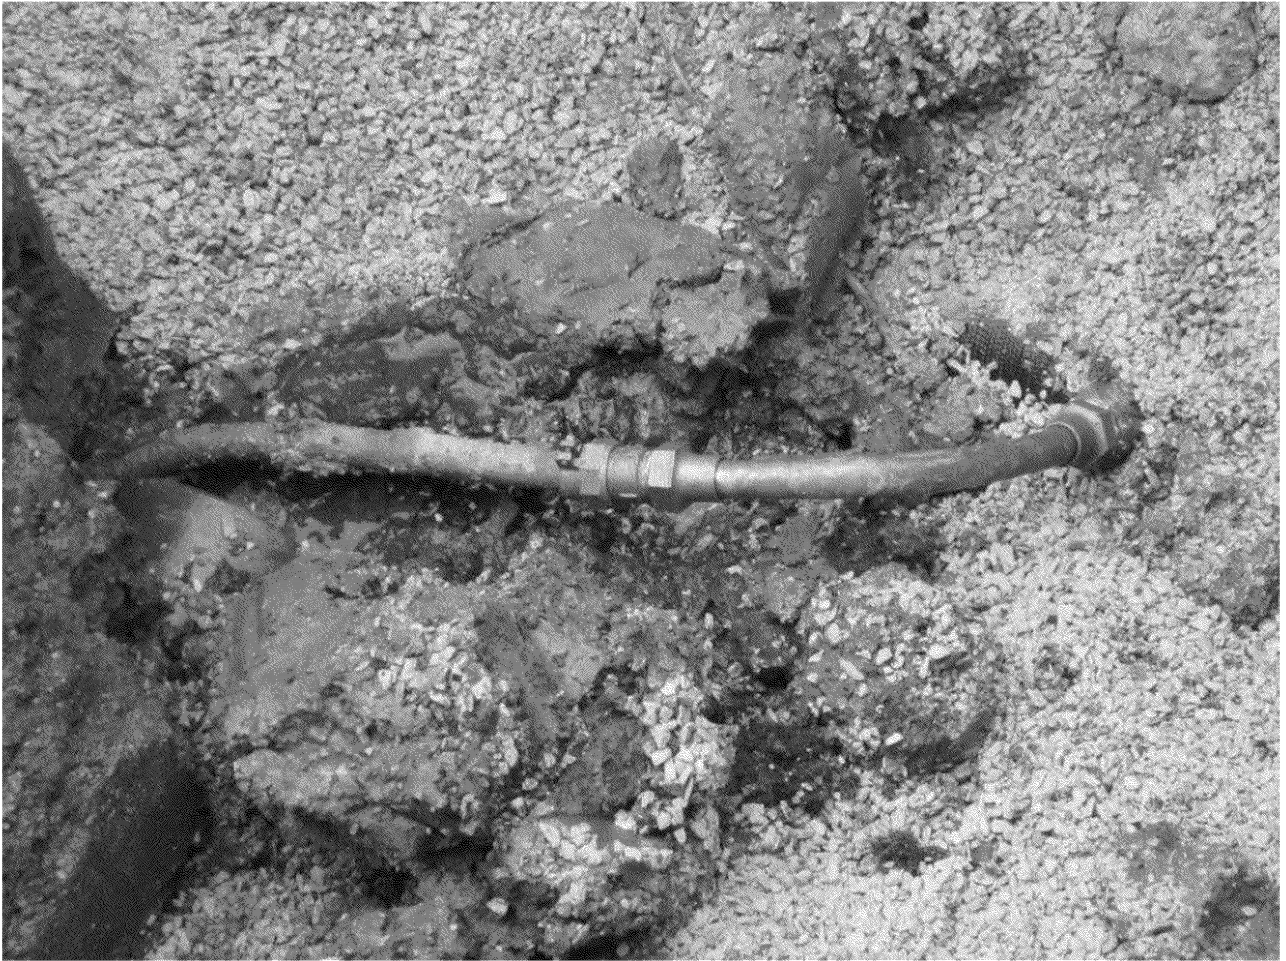
Once all is tightened and there are no leaks, the work here is done.

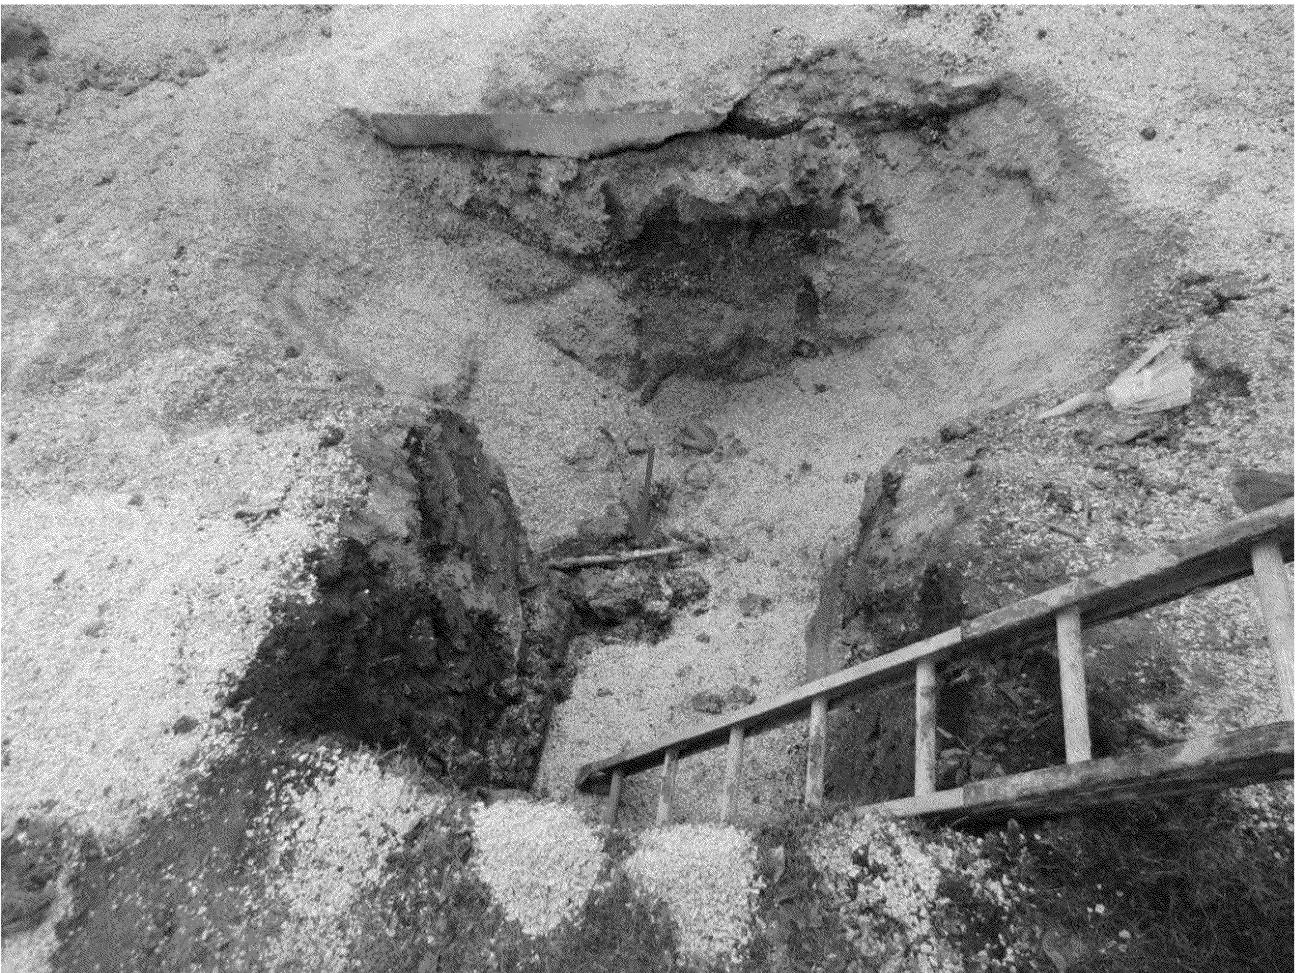
View of final connection from the sidewalk level

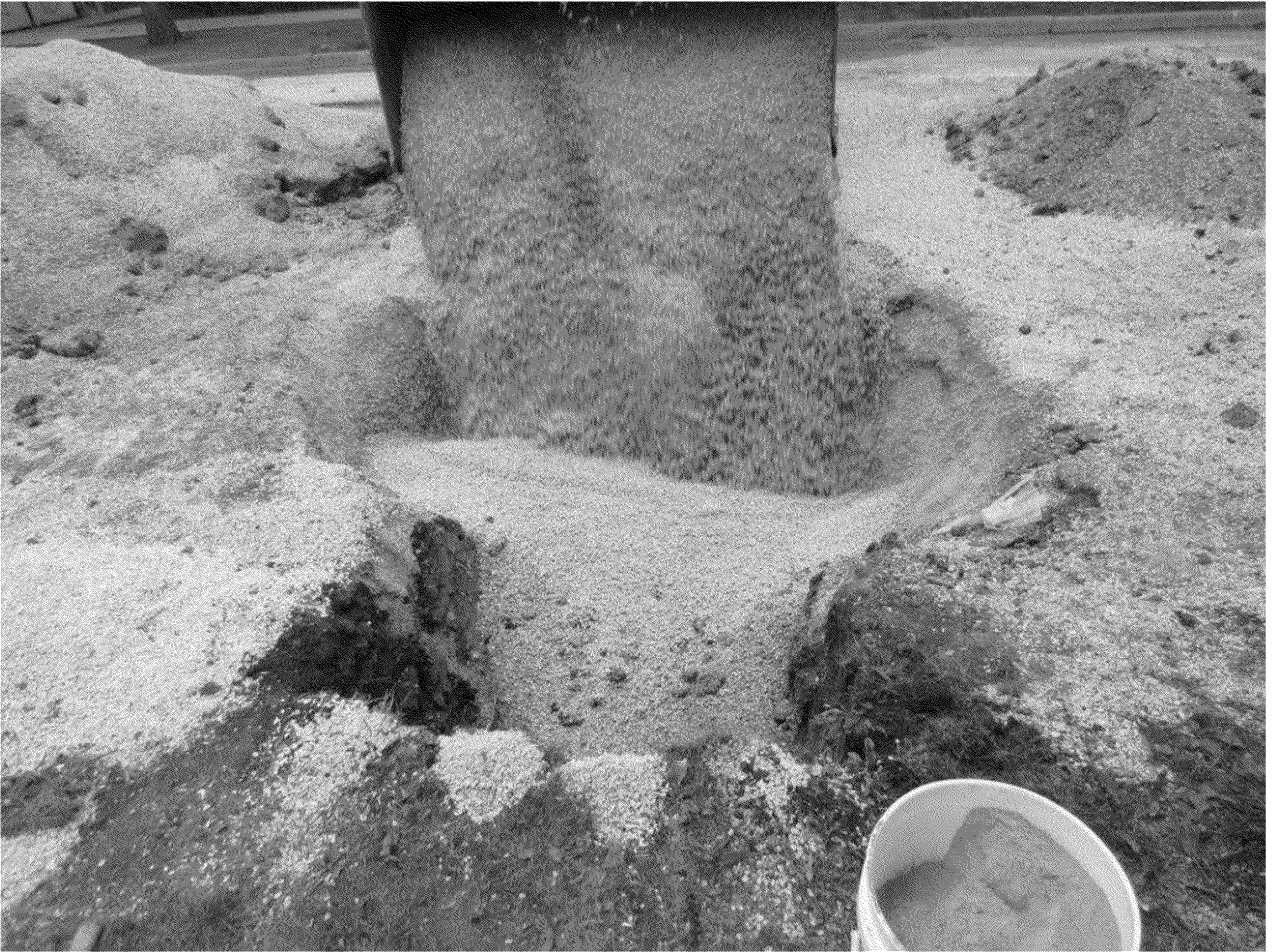
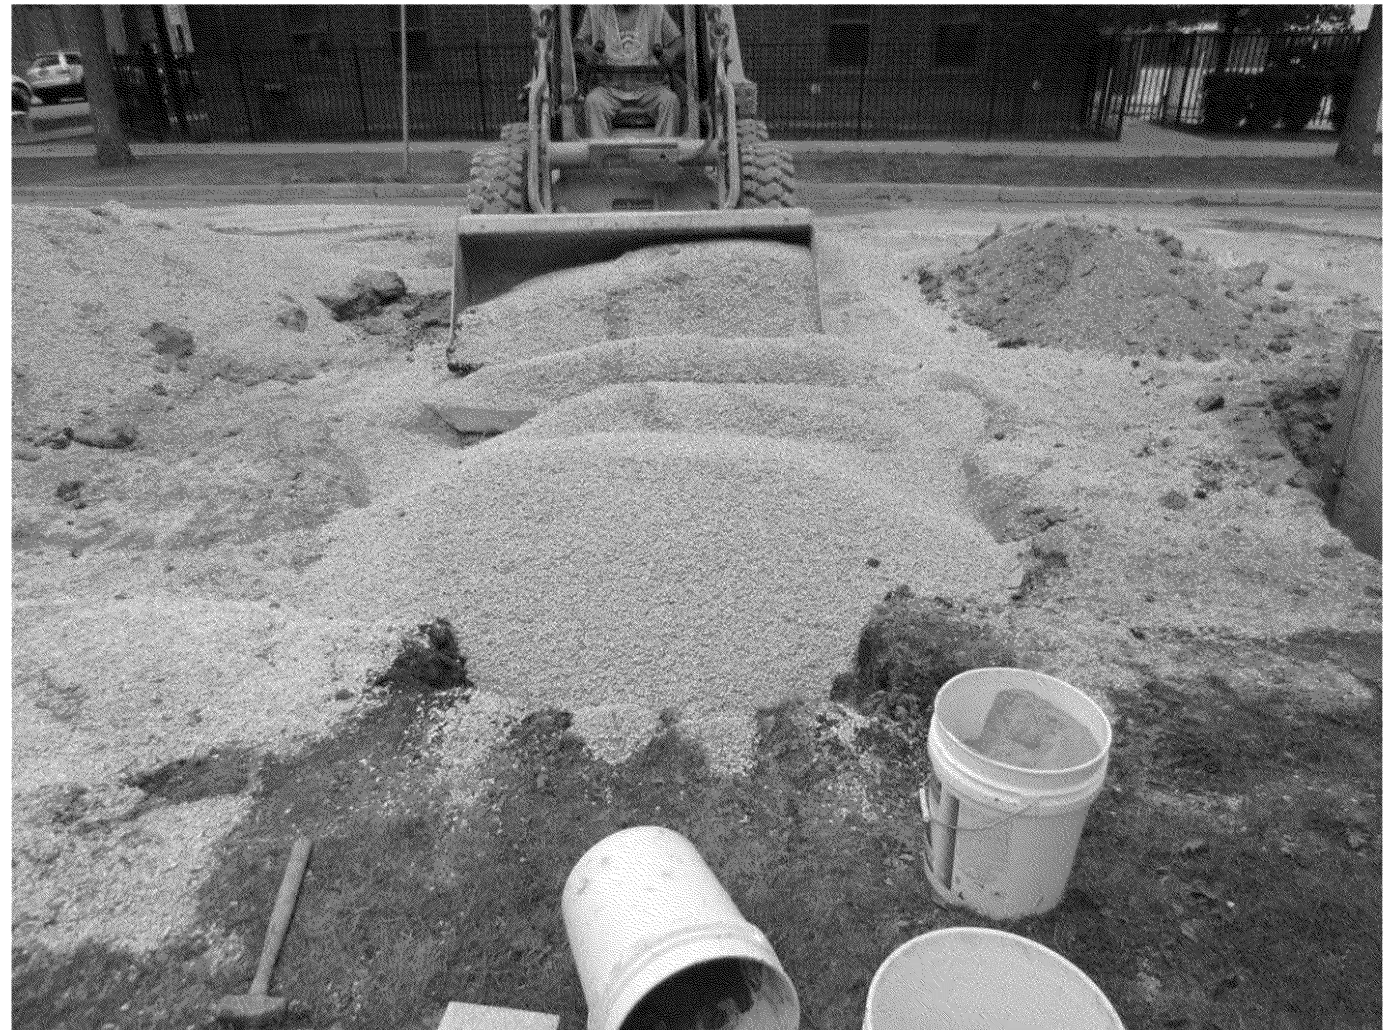
Once the connection is made and there are no leaks, the trench is filled with gravel

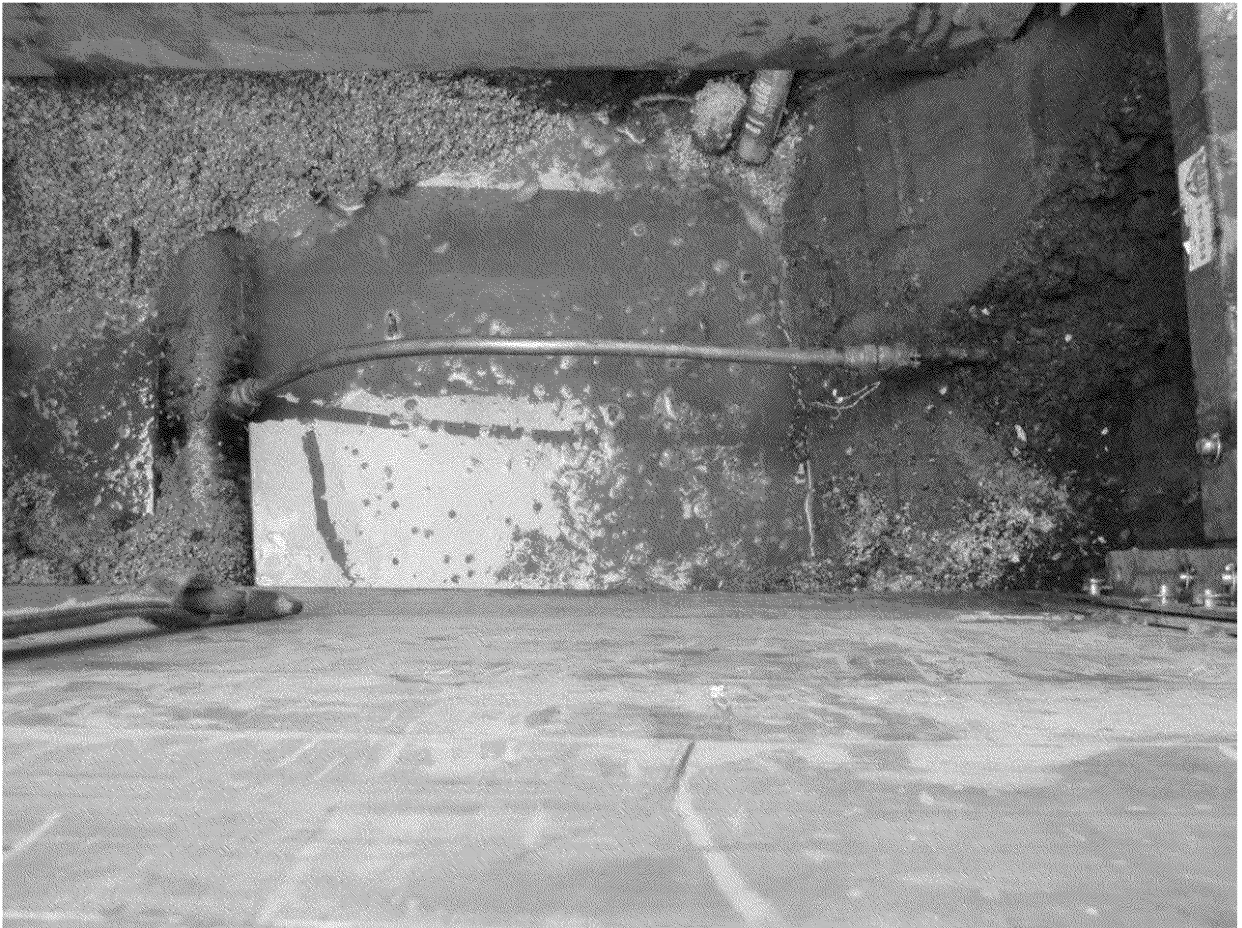
The previous pictures were a connection to the near side home. This copper connection is longer, going across the trench since the home is on the other side of the street.

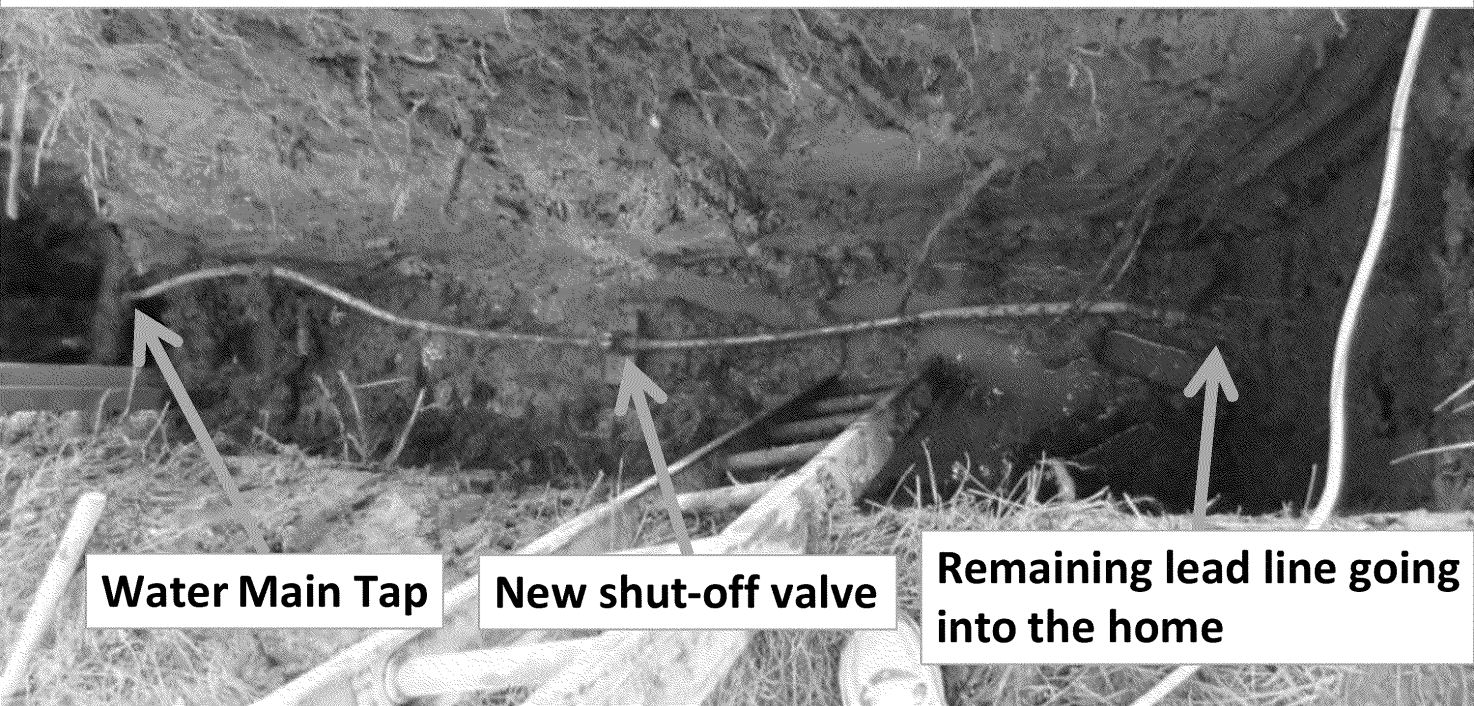
The excavation work in the street caused a leak in the existing lead service line, so a lateral trench was dug along the lead line to reach the leak. An additional length of the lead line was removed and replaced with copper pipe and a new shut-off valve was installed.

In this picture the lead line was replaced with copper pipe from the main to the edge of the sidewalk at the right.

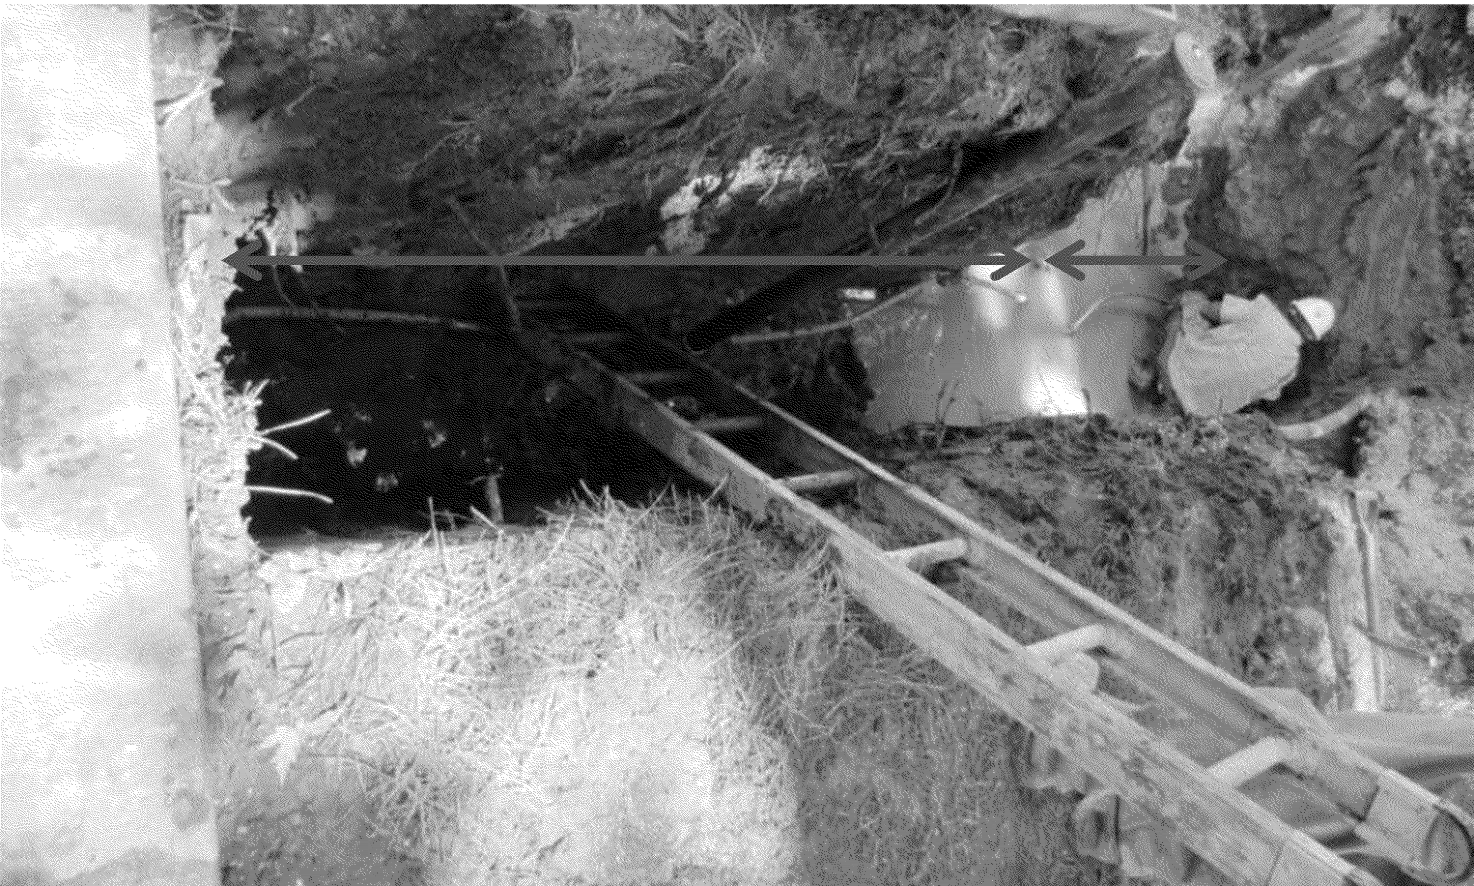
This is the same location as the last slide. Another (shorter) segment of copper pipe is connected to the lead line serving the home across the street.

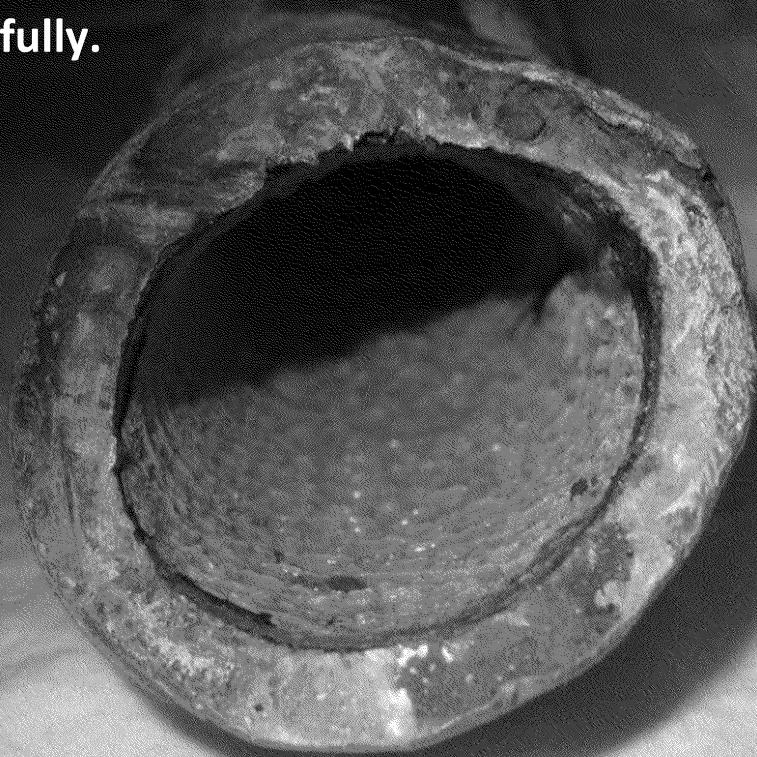
This is the scale inside from a lead service line that was removed carefully, so the scale remains mostly intact. Some of the pipe we recovered had little to no scale left inside, where the pipe was not handled as carefully.

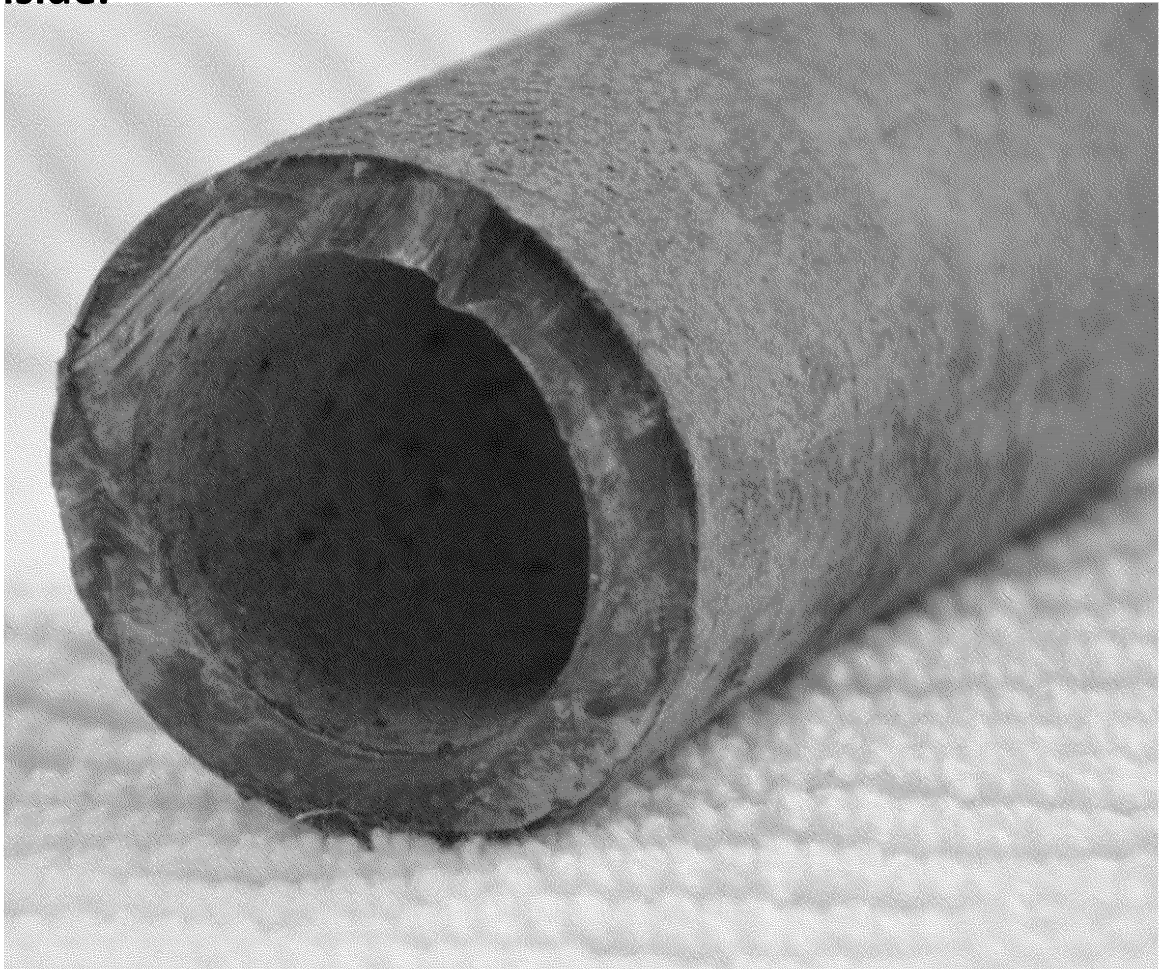
This section of lead pipe which was extracted has only residual scale left inside.
